Condition Assessment
&
Reserve Fund Plan Update
2019
Southgate
Square
Reston, Virginia

November 9, 2018

RE: **CONDITION ASSESSMENT AND RESERVE FUND PLAN UPDATE 2019**
Southgate Square Cluster Association
Reston, Virginia
Project No. 8723

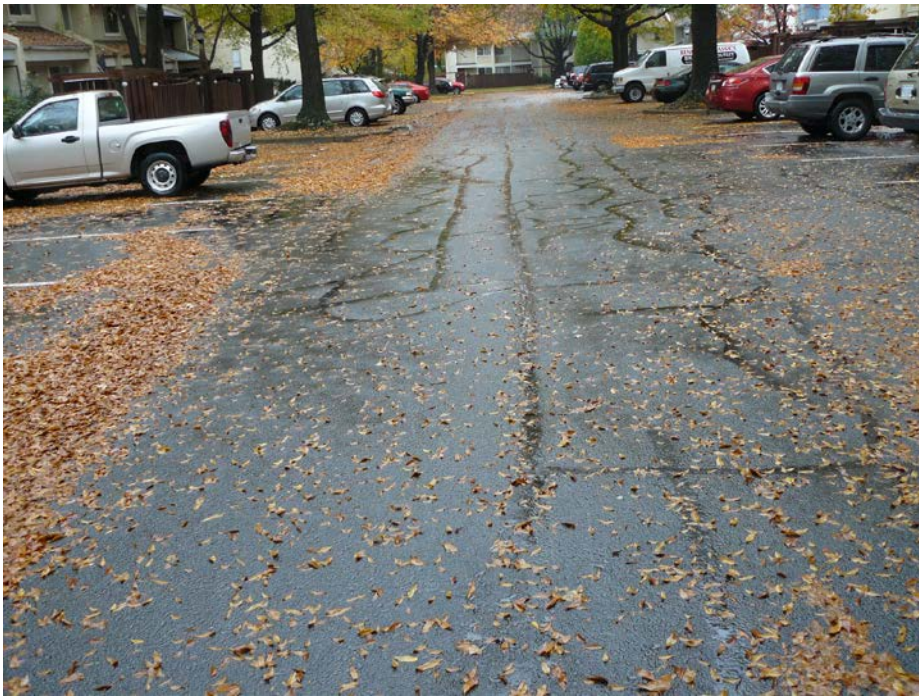
PHOTO #1

The asphalt driveways and parking bays range from fair to good condition. Some areas were difficult to observe, as heavy leaf foliage was present.

| Reserve Fund Plan for SOUTHGATE SQUARE CLUSTER ASSOCIATION Reston, Virginia | | | | | COMPONENT DATA AND ASSET REPLACEMENT SCHEDULE TABLE 1 2019 Through 2038 | | | | | | | | | | | | MASON & MASON CAPITAL RESERVE ANALYSTS, INC. www.masonreserves.com 800-776-6980 Fax 800-776-6408 <small>Copyright © 1999 All rights reserved.</small> | | DISCUSSION |
|--|---|---|---|---|--|---|---|---|---|---|---|---|---|---|---|---|---|--|---|
| 1.1 | Asphalt Restoration Project | 10,592 | SY | \$12.50 | \$132,400 | 18 | 2023 | 100% | \$149,017 | 2041 | 100% | \$253,692 | | | | This component includes asphalt drivelan es and parking bays of the community. Neither the depth nor the sub-base of the pavement could be visually determined. It appears that the pavement was restored circa 2003, and it is in fair to good condition. Minor areas of deflective cracking (indicative of sub-base damage or insufficient asphalt depth) were observed on the drivelan es or parking bays. Restoration includes full-width profile milling and new compacted asphalt. Core sampling should be used to determine the depth and condition of the sub-base and pavement prior to restoration. Costs include striping, but not replacement of any inadequate sub-base. | | | |

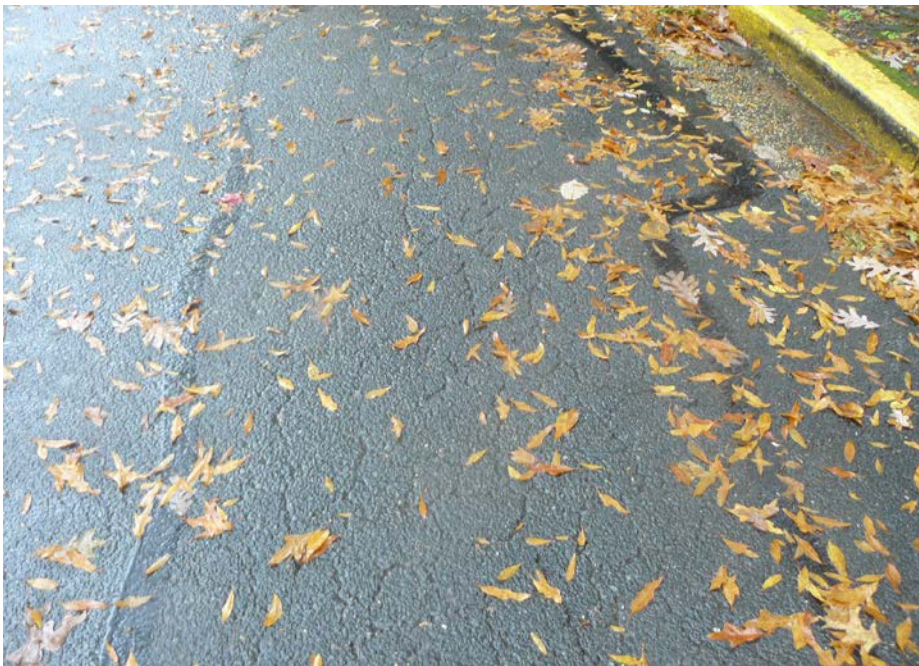
PHOTO #2

Some deflected pavement was observed. Full restoration of the asphalt (full-width profile milling and new compacted asphalt) is scheduled in about four years.

| Reserve Fund Plan for SOUTHGATE SQUARE CLUSTER ASSOCIATION Reston, Virginia | | | | | COMPONENT DATA AND ASSET REPLACEMENT SCHEDULE TABLE 1 2019 Through 2038 | | | | | | | | | | | | MASON & MASON CAPITAL RESERVE ANALYSTS, INC. www.masonreserves.com 800-776-6980 Fax 800-776-6408 <small>Copyright © 1999 All rights reserved.</small> | | DISCUSSION |
|--|---|---|---|---|--|---|---|---|---|---|---|---|---|---|---|---|---|--|---|
| 1.3 | Asphalt Repair Allowance | 1 | LS | \$18,000.00 | \$18,000 | 6 | 2023 | 100% | \$20,259 | 2029 | 25% | \$6,048 | 2035 | 50% | \$14,442 | Approximately 25 square yards of alligator cracked or deflected pavement (indicative of sub-base damage), and about 420 linear feet of non-filled longitudinal or transverse cracking was observed. Repairs are essential in order to achieve the projected remaining service life of the pavement. Full-depth repairs and crack filling are scheduled every six years throughout the study period, including the year of the asphalt restoration project. | | | |

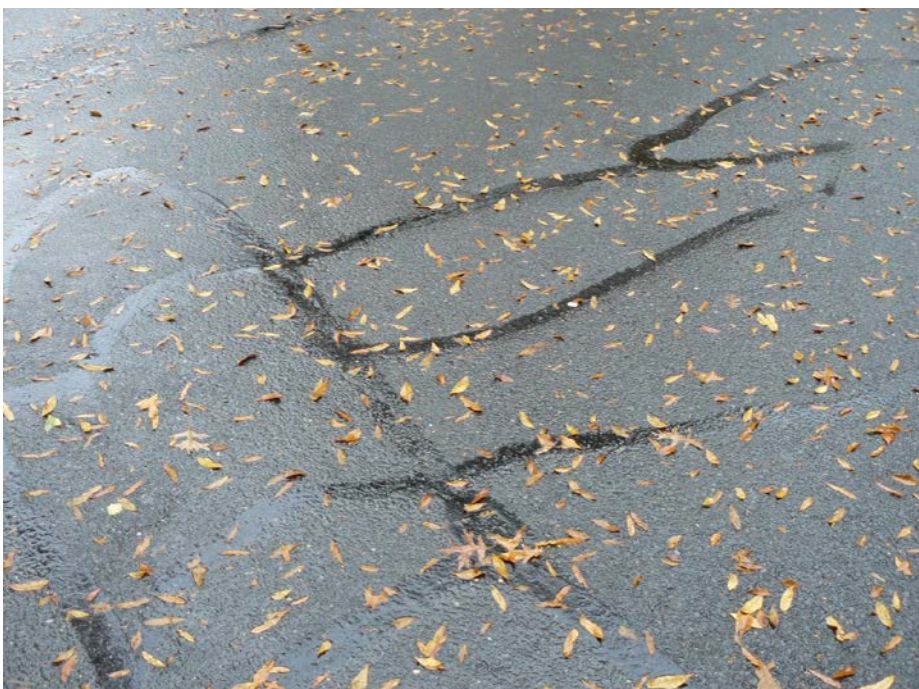
PHOTO #3

Most longitudinal and transverse cracking was filled circa 2017. Pavement maintenance should include full-depth repair of deflected pavement, crack filling, and seal coating, every six years.

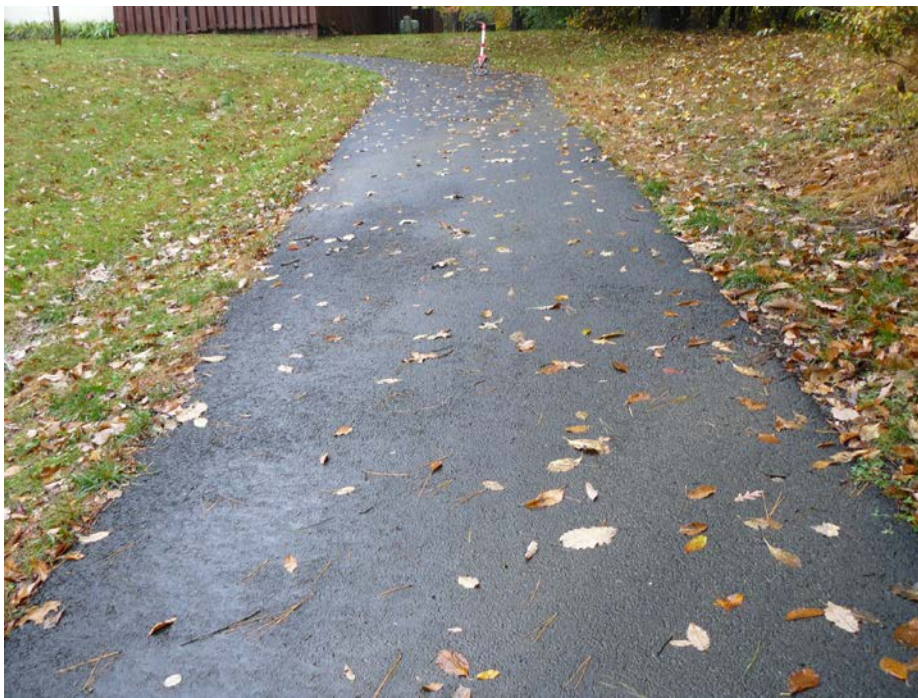
PHOTO #4

The asphalt footpaths range from fair to generally continuing good condition.

| Reserve Fund Plan for SOUTHGATE SQUARE CLUSTER ASSOCIATION Reston, Virginia | | | | | COMPONENT DATA AND ASSET REPLACEMENT SCHEDULE TABLE 1 2019 Through 2038 | | | | | | | | | | | | MASON & MASON CAPITAL RESERVE ANALYSTS, INC. www.masonreserves.com 800-776-6980 Fax 800-776-6408 <small>Copyright © 1999 All rights reserved.</small> | | DISCUSSION |
|--|---|---|---|---|--|---|---|---|---|---|---|---|---|---|---|---|---|--|---|
| 1.4 | Asphalt Footpaths | 499 | SY | \$36.00 | \$17,964 | 15 | 2028 | 50% | \$11,719 | 2034 | 50% | \$13,994 | 2040 | 50% | \$16,709 | Asphalt footpaths generally 4' and 8' in width are constructed throughout the community. The 4' path constructed between the townhomes and the west side tot lot is in fair to good condition. The 8' path constructed between the townhomes and Reston Parkway is in good condition. Delineation between Southgate Square and Reston Association path ownership is difficult to determine and is based on location of the Southgate Square HOA property sign on this path. Any trip hazards or hazardous surface deficiencies should be addressed as soon as practicable to prevent personal injury. | | | |

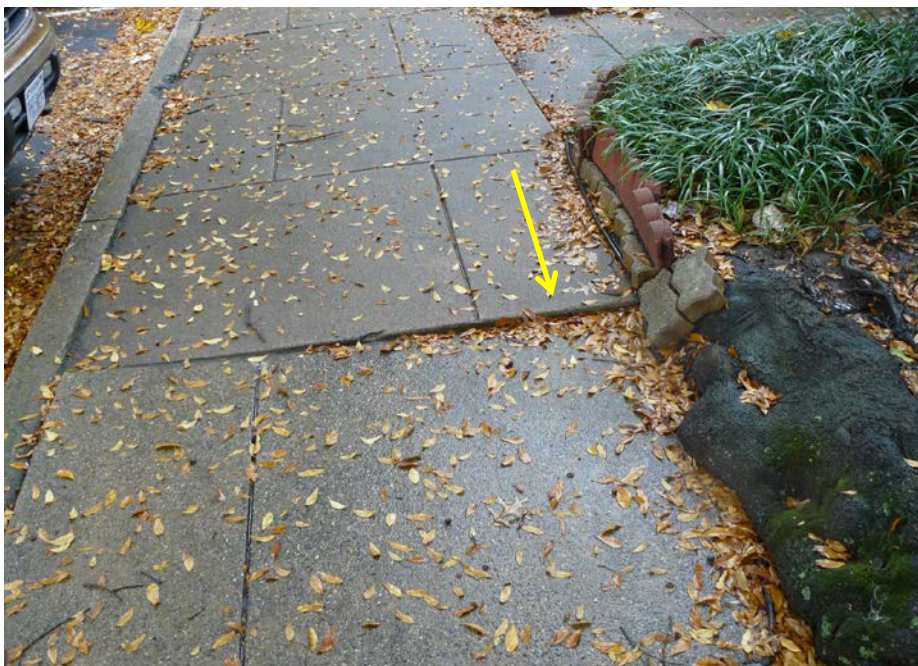
PHOTO #5

There is a significant quantity of cracked, settled and/or heaved concrete sidewalks, which are potential tripping hazards. This is mainly due to the significant tree root systems throughout the community. The liability and costs associated with personal injury lawsuits resulting primarily from sidewalk and curb tripping hazards are too great to defer repair. It is our opinion that addressing deficiencies, which pose a hazard to pedestrians, should not be deferred. As such, we recommend correcting the significant tripping hazards observed throughout the sidewalks as soon as practicable.

Many concrete sidewalk panels are heaved or settled, due to significant tree root systems. These height differentials are potential tripping hazards, which should be repaired when present.

| Reserve Fund Plan for SOUTHGATE SQUARE CLUSTER ASSOCIATION Reston, Virginia | | | | | COMPONENT DATA AND ASSET REPLACEMENT SCHEDULE TABLE 1 2019 Through 2038 | | | | | | | | | | | | MASON & MASON CAPITAL RESERVE ANALYSTS, INC. www.masonreserves.com 800-776-6980 Fax 800-776-6408 <small>Copyright © 1999 All rights reserved.</small> | | DISCUSSION |
|--|---|---|---|---|--|---|---|---|---|---|---|---|---|---|---|---|---|--|---|
| 2.1 | Concrete Sidewalks | 30,524 | SF | \$11.50 | \$351,026 | 5 | 2019 | 3% | \$10,531 | 2024 | 4% | \$16,277 | 2029 | 4% | \$18,870 | Concrete sidewalks, generally 4' and 6' wide, are present on one or both sides of streets within the community. Their thickness could not be visually determined. They range from fair to good condition with a significant number of tripping hazards observed. About 880 square feet (2.8% of the total area) is either cracked, settled or heaved between sections. We have not scheduled replacement of all sections with lesser surface defects. Severely scaled sections will tend to deteriorate more quickly over time and should be replaced in each replacement cycle. Cyclic repairs are scheduled, as full replacement at one time is not appropriate or anticipated. Concrete repairs are scheduled to coincide with work on other concrete components to take advantage of economies of scale in packaging concrete restoration work. Any trip hazards or surface deficiencies should be addressed as soon as practicable to prevent personal injury. | | | |

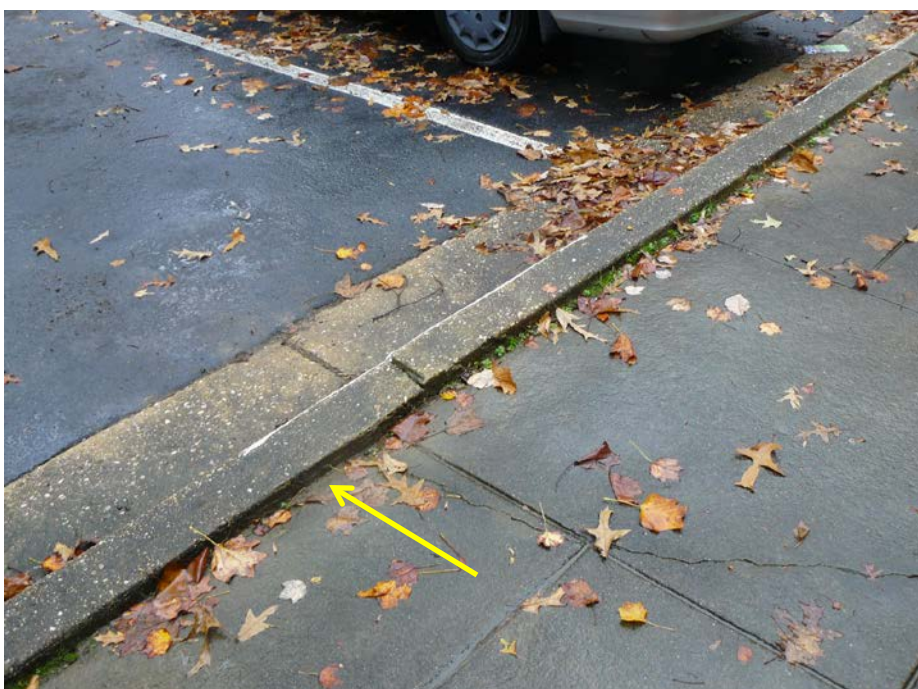
PHOTO #6

Several lineal areas of concrete sidewalk panels settled at curbs were identified, which are also potential tripping hazards, requiring repair.

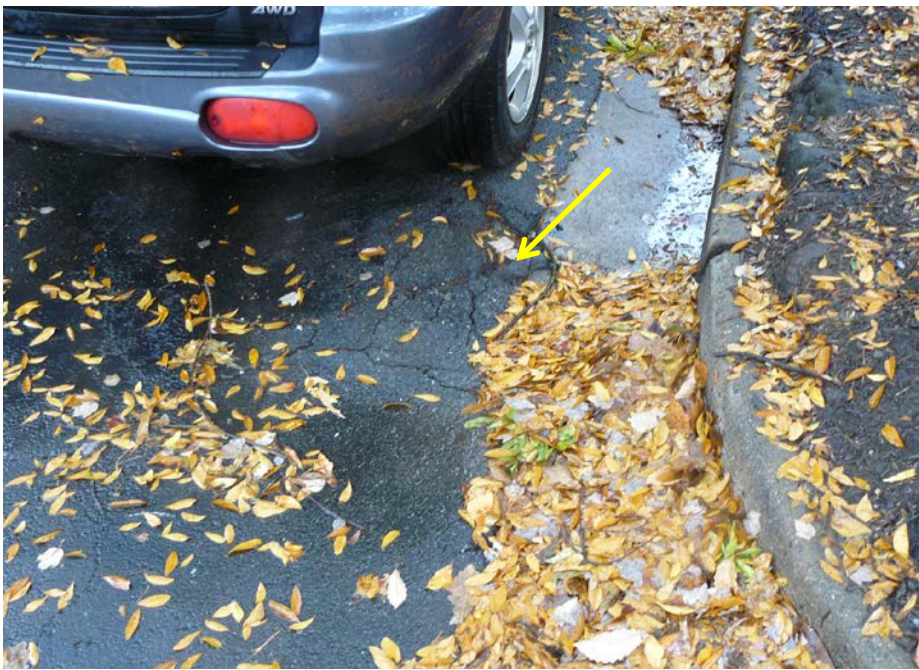
PHOTO #7

Most of the concrete curbs and gutters are in continuing good condition. Some of the root systems are working their way under the pavement and are beginning to heave the asphalt.

| Reserve Fund Plan for SOUTHGATE SQUARE CLUSTER ASSOCIATION Reston, Virginia | | | | | COMPONENT DATA AND ASSET REPLACEMENT SCHEDULE TABLE 1 2019 Through 2038 | | | | | | | | | | | | MASON & MASON CAPITAL RESERVE ANALYSTS, INC. www.masonreserves.com 800-776-6980 Fax 800-776-6408 <small>Copyright © 1999 All rights reserved.</small> | | DISCUSSION |
|--|---|---|---|---|--|---|---|---|---|---|---|---|---|---|---|---|---|--|---|
| 2.2 | Concrete Curbs & Gutters | 5,938 | LF | \$36.00 | \$213,768 | 5 | 2019 | 2% | \$4,275 | 2024 | 3% | \$7,434 | 2029 | 3% | \$8,619 | The drivelan es and parking bays are lined with standard-profile, cast-in-place, concrete curbs and gutters. They are in generally continuing good condition with about 2% of the length exhibiting transverse cracks or settled sections. We observed approximately 12 damaged sections, the worst of which should be replaced. Minor chips usually do not justify replacement. Cyclic repairs are scheduled, as full replacement at one time is not appropriate or anticipated. Curb repairs are scheduled to coincide with work on other concrete components to maximize economies of scale. Any trip hazards or surface deficiencies should be addressed as soon as practicable to prevent personal injury. | | | |

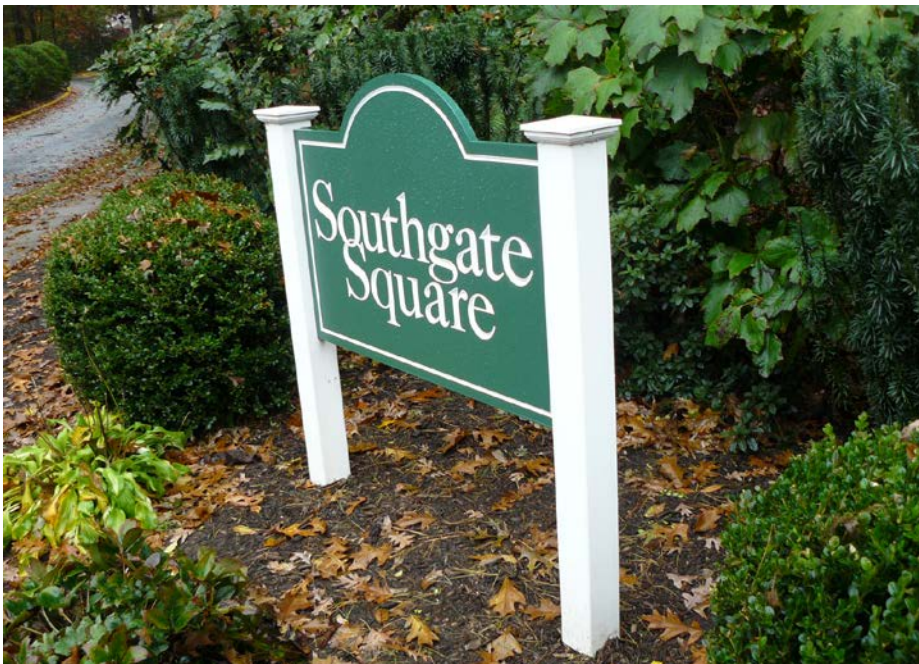
PHOTO #8

The entrance sign was recently replaced and is in good condition.

| Reserve Fund Plan for SOUTHGATE SQUARE CLUSTER ASSOCIATION Reston, Virginia | | | | | COMPONENT DATA AND ASSET REPLACEMENT SCHEDULE TABLE 1 2019 Through 2038 | | | | | | | | | | | | MASON & MASON CAPITAL RESERVE ANALYSTS, INC. www.masonreserves.com 800-776-6980 Fax 800-776-6408 <small>Copyright © 1999 All rights reserved.</small> | | DISCUSSION |
|--|---|---|---|---|--|---|---|---|---|---|---|---|---|---|---|---|---|--|---|
| 3.1 | Entrance Signage | 1 | EA | \$2,500.00 | \$2,500 | 15 | 2032 | 100% | \$3,671 | 2047 | 100% | \$5,720 | | | | A painted, MDF (Medium Density Fiberboard) sign is installed at the entrance to the community on South Lakes Drive. The sign measures six feet by three feet high and is mounted on two, 4 x 4 vinyl posts. No landscape lighting or irrigation systems were observed. The sign was installed circa 2017 and is in very good condition. | | | |

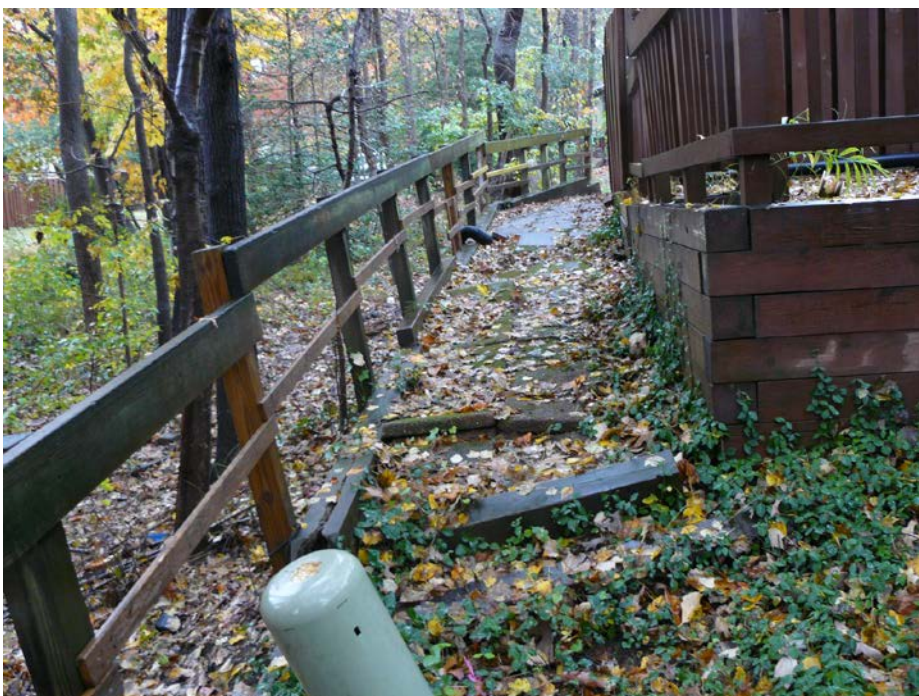
PHOTO #9

The retaining wall and handrailings installed behind unit 2365 are in fair condition. However, severe tripping hazards have still not been repaired in this area.

| Reserve Fund Plan for SOUTHGATE SQUARE CLUSTER ASSOCIATION Reston, Virginia | | | | | COMPONENT DATA AND ASSET REPLACEMENT SCHEDULE TABLE 1 2019 Through 2038 | | | | | | | | | | | | MASON & MASON CAPITAL RESERVE ANALYSTS, INC. www.masonreserves.com 800-776-6980 Fax 800-776-6408 <small>Copyright © 1999 All rights reserved.</small> | | DISCUSSION |
|--|---|---|---|---|--|---|---|---|---|---|---|---|---|---|---|---|---|--|---|
| 3.2 | Timber Retaining Walls | 978 | SF | \$38.00 | \$37,164 | 20 | 2020 | 100% | \$38,279 | 2040 | 100% | \$69,136 | | | | Pressure-treated retaining walls are constructed of 6" by 6" timbers at two grade differentials within the community. The walls constructed at the east tot lot are in fair condition. The wall and handrailing constructed below the townhomes on the west side of the community is also in fair condition, but the path above this wall, which appears to be on common property and serves several rear townhome entrances, continues to be in dangerous condition. Extreme tripping hazards were observed at this location. This path should be repaired under Operations as soon as possible. | | | |

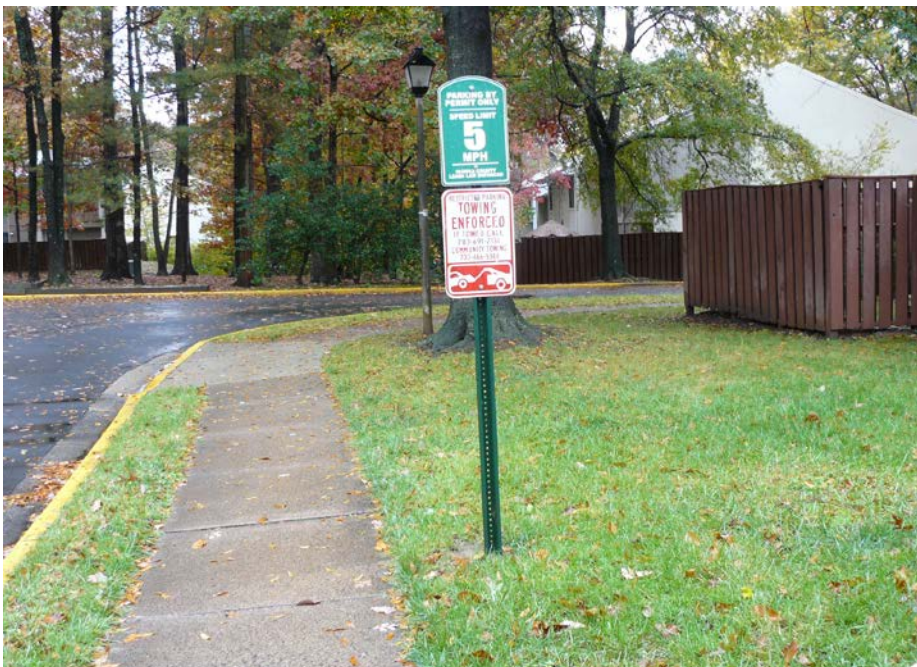
PHOTO #10
The street and informational signage ranges from fair to generally continuing good condition.

| Reserve Fund Plan for SOUTHGATE SQUARE CLUSTER ASSOCIATION Reston, Virginia | | | | | COMPONENT DATA AND ASSET REPLACEMENT SCHEDULE TABLE 1 2019 Through 2038 | | | | | | | | | | | | MASON & MASON CAPITAL RESERVE ANALYSTS, INC. www.masonreserves.com 800-776-6980 Fax 800-776-6408 <small>Copyright © 1999 All rights reserved.</small> | | DISCUSSION |
|--|---|---|---|---|--|---|---|---|---|---|---|---|---|---|---|---|---|--|---|
| 3.3 | Street and Informational Signage | 13 | EA | \$155.00 | \$2,015 | 20 | 2027 | 50% | \$1,276 | 2037 | 50% | \$1,715 | 2047 | 50% | \$2,305 | Standard metal traffic, parking, and access control signs, typically 12" by 18", mounted on perforated metal posts, and one timber sign are located throughout the community. A total of approximately nine signs and four 'Fido' dog clean up stations were observed. Posts and signs appear to range from good to fair condition, with faded and out-of-plumb signs observed. | | | |

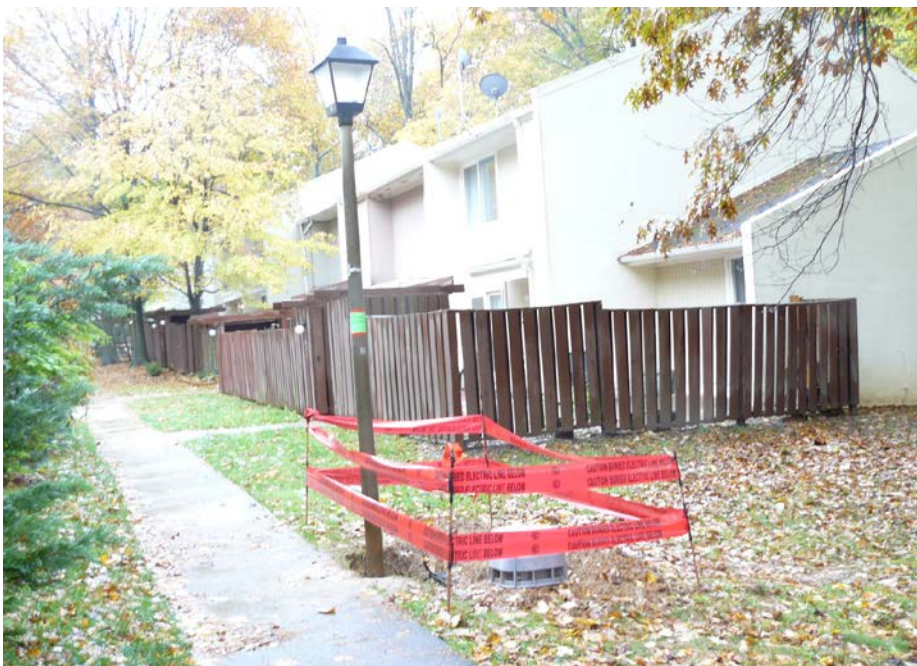
PHOTO #11
The concrete light poles and fixtures appear to be in fair condition. One light was in the process of having the underground wiring replaced. We have scheduled street light replacement near-term, as these fixtures and wiring are deteriorating.

| Component No. | Component | Quantity | Unit of Measurement | Unit Cost | Total Asset Base | Typical Service or Cycle Life in Yrs | 1st Cycle Year | Percentage of Replacement | Cost For 1st Cycle | 2nd Cycle Year | Percentage of Replacement | Cost For 2nd Cycle | 3rd Cycle Year | Percentage of Replacement | Cost For 3rd Cycle | DISCUSSION |
|---|---|---|---|---|---|---|---|---|---|---|---|---|---|---|---|---|
| 3.4 | Light Poles & Fixtures | 23 | EA | \$3,200.00 | \$73,600 | 35 | 2020 | 100% | \$75,808 | 2055 | 100% | \$213,313 | | | | A Board member previously advised us that the community is responsible for replacement of the street lights, even though they were originally installed by Dominion Power. Approximately 23 concrete light poles, about 12' high, with traditional lantern fixtures provide street and area illumination. Maintenance of the lights is completed through Dominion Power and billed to the Cluster Association. Most light poles and fixtures are in fair condition. Some poles were observed out of plumb and some fixture lenses were missing. The wiring of one pole was being replaced as we were on-site. We are budgeting for replacement and installation of typical fiberglass reinforced plastic (FRP) light poles and fixtures. The lighting was not observed after dark. No problems were reported with lighting. |

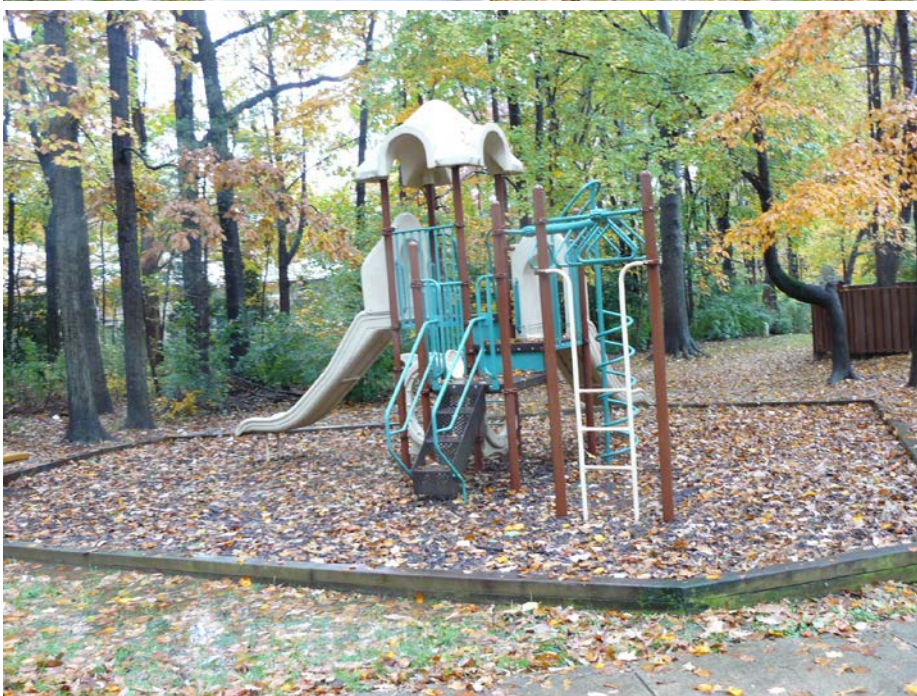
PHOTO #12
Both of the tot lots appear to be in fair condition. Pressure-washing/cleaning the play modules may help to maximize the service life. If this is accomplished, the play module replacement may be deferred by a couple of years.
